# Guntruck Iraq 2003 - scale 1/35

21/05/2011

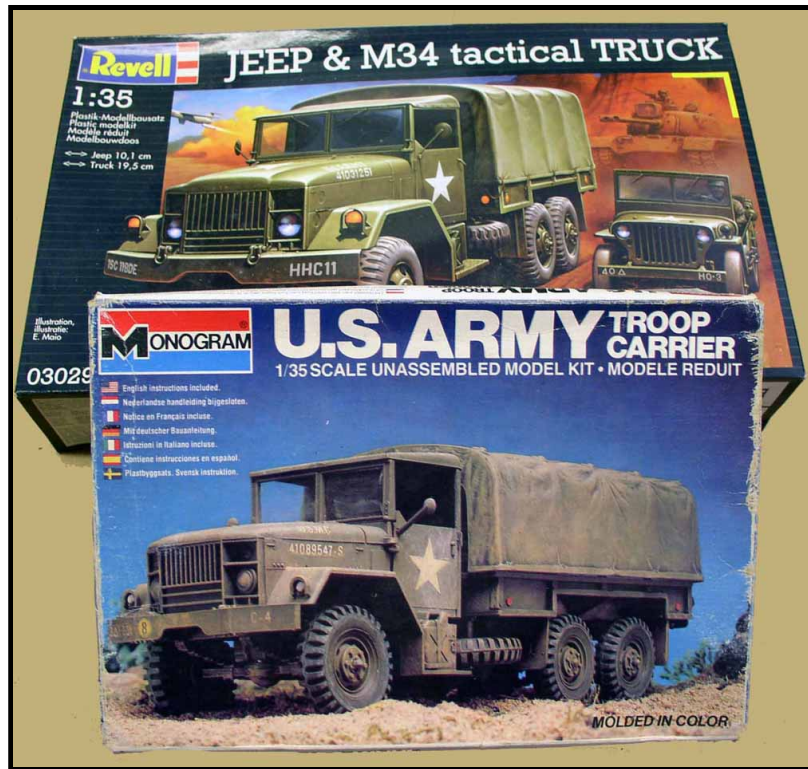
The basic kit for building this model is an M34 (or M35 from AFV-CLUB), which most closely resembles the 818—a model that has never been produced as a plastic or resin kit... Revell has reissued this model—with a Jeep thrown in as a bonus—an older kit that isn't very accurate...

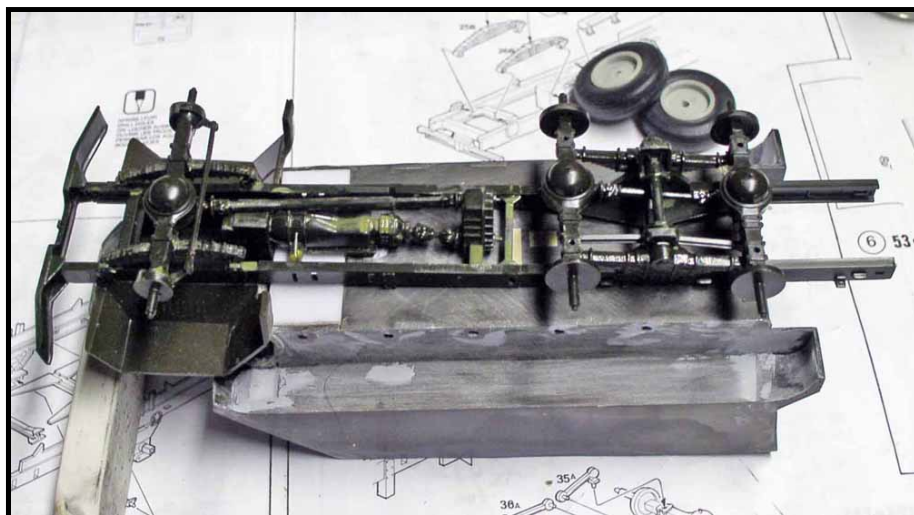
First challenge: adapting the M113's chassis, nose, and body. The truck's chassis comes from a 923—which is more accurate than that of the M34—and has simply been shortened to the correct length... The M113's shock absorbers are ground down, and holes are drilled where they would go...

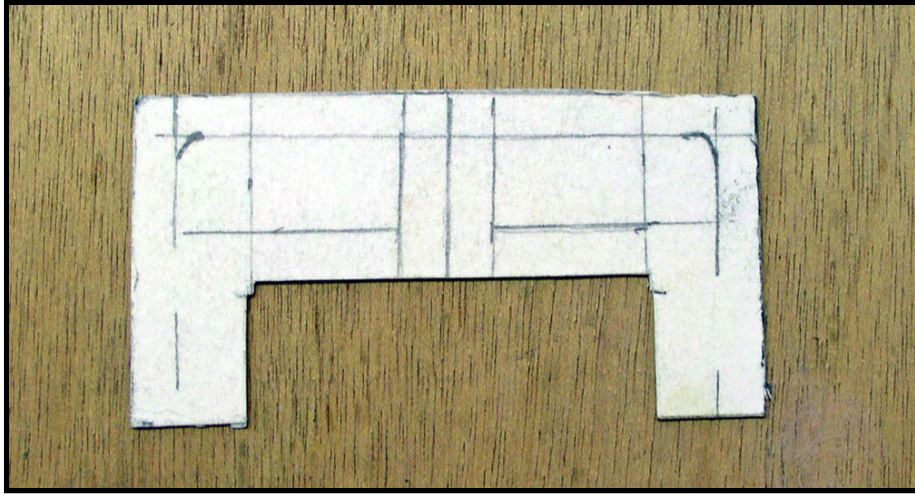
A cardboard template will help determine the placement of the future windows and replace the front windshield of the M113...

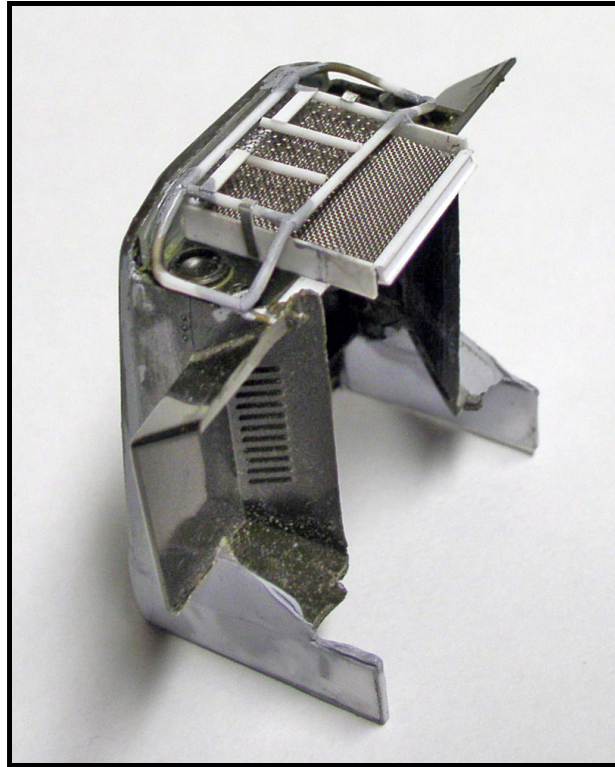
The M34's grille has been modified. The headlights have been raised. A new radiator has been built. The protective bar typical of the 818 models is made from Evergreen rod. Photo-etched wire mesh will complete the assembly. The hood has been lengthened by a good centimeter...

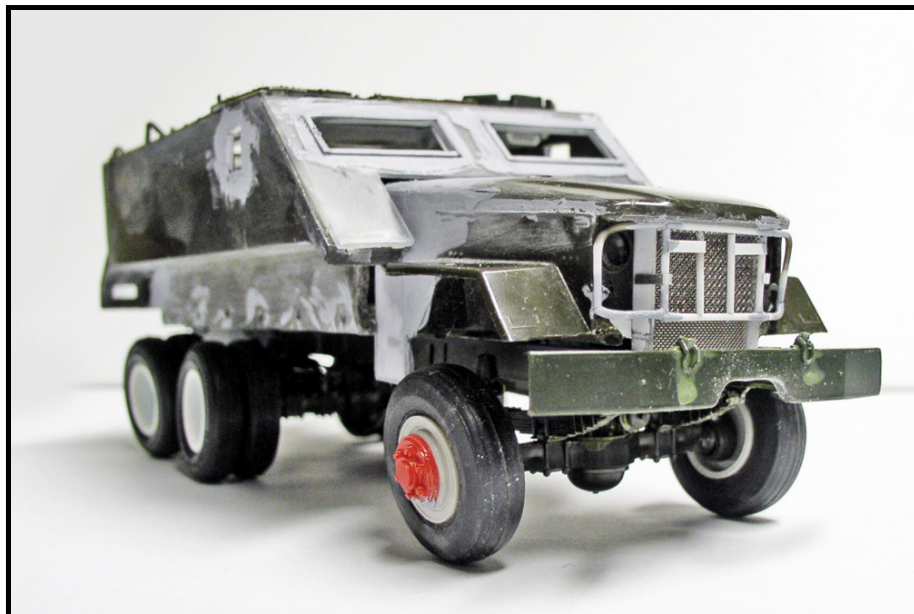
Attaching the main components after cutting window openings in the M113's hull. The wheels, simply placed there, give a sense of scale. The wheels from the M34 and the 923 don't fit at all, since the original uses civilian truck axles! I decided to use 1/24-scale car models, since the tire design is that of a civilian truck and the size is as close as possible to the kit...

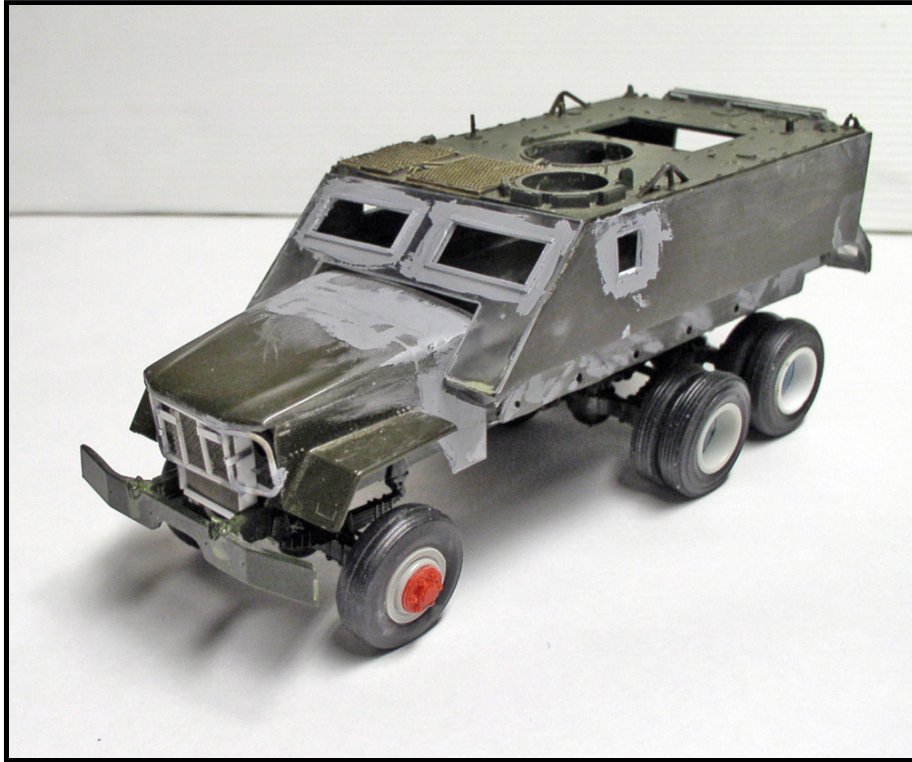
Top view: You can clearly see the cutouts and the extended hood designed to fit into the M113's glasis...

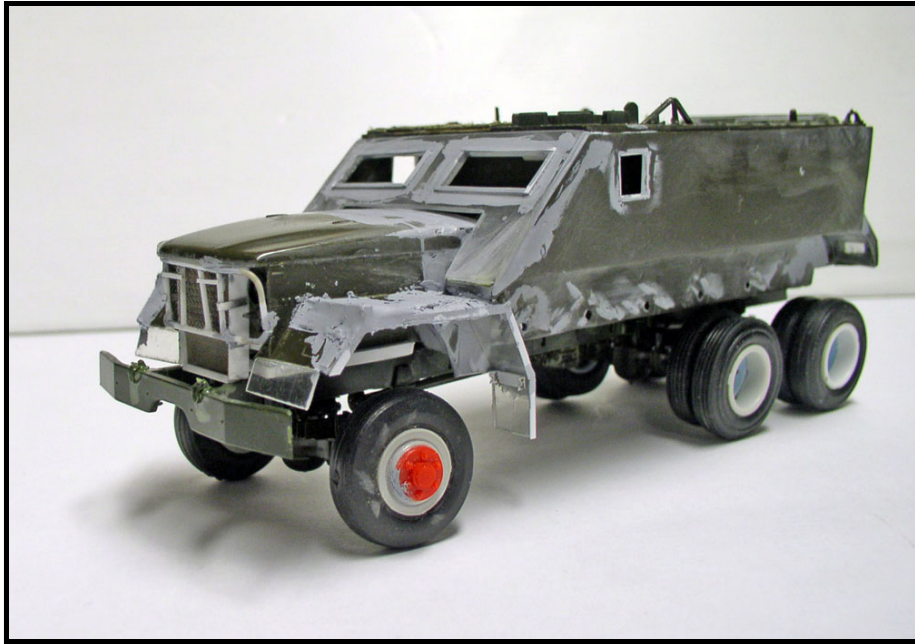
Mudguards that aren't wide or long enough are modified and filled with putty to eliminate the seams...

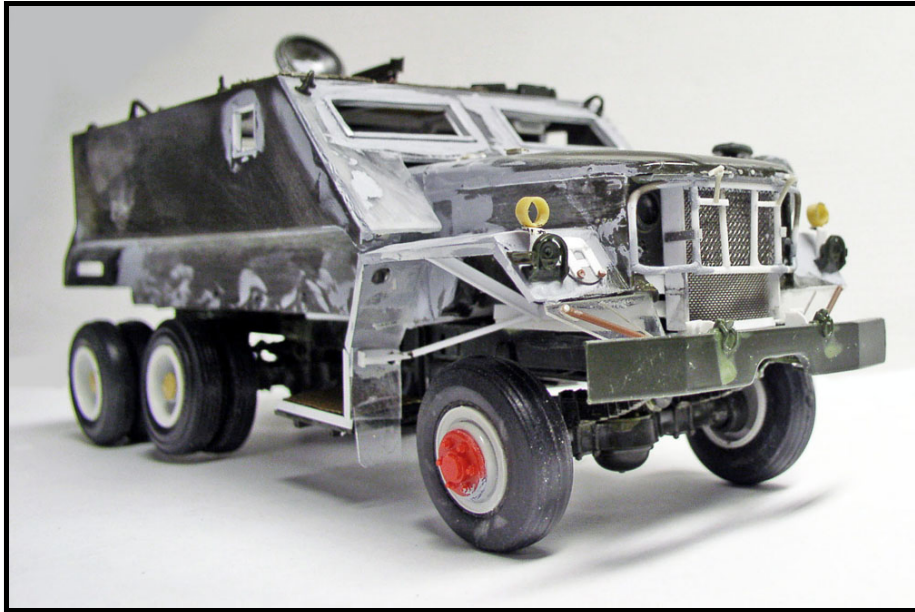
Installing the fender reinforcements and the fender lights...

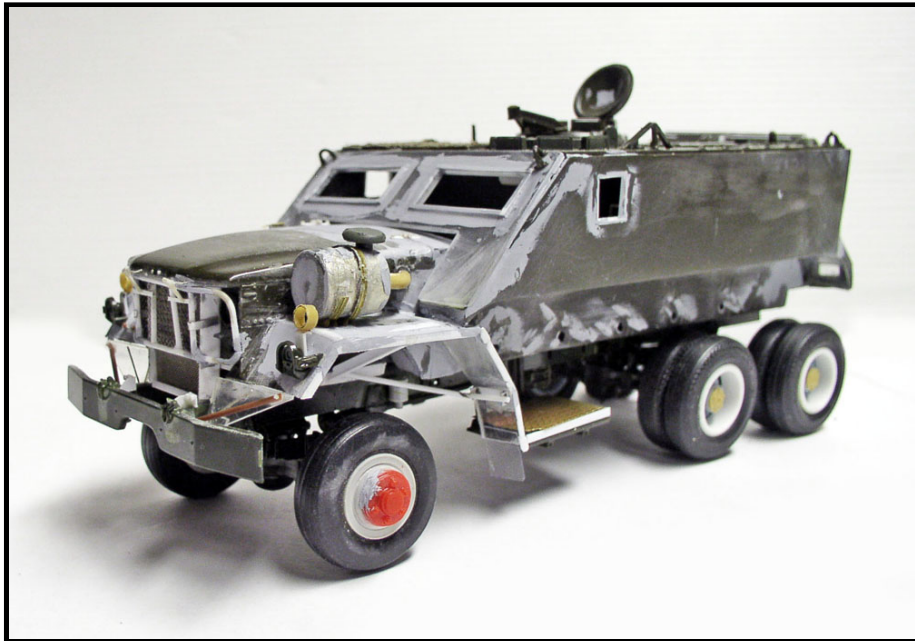
Installation of the air filter and the steps supporting the fuel tanks and batteries. These parts come from the 923 and have been slightly modified...

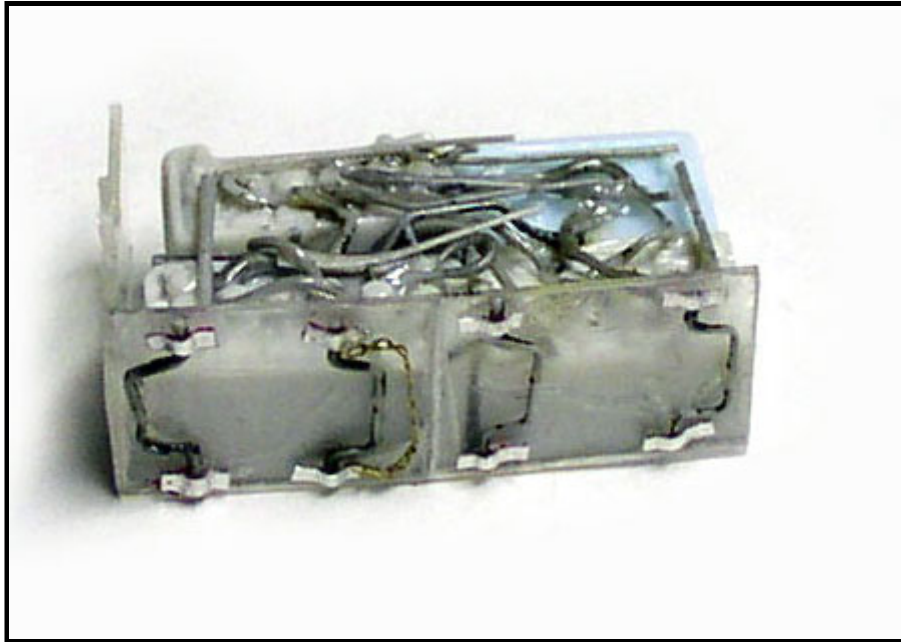
The battery compartment is made of plastic. The batteries come from 1/24-scale motor kits... Wiring and handles are added...

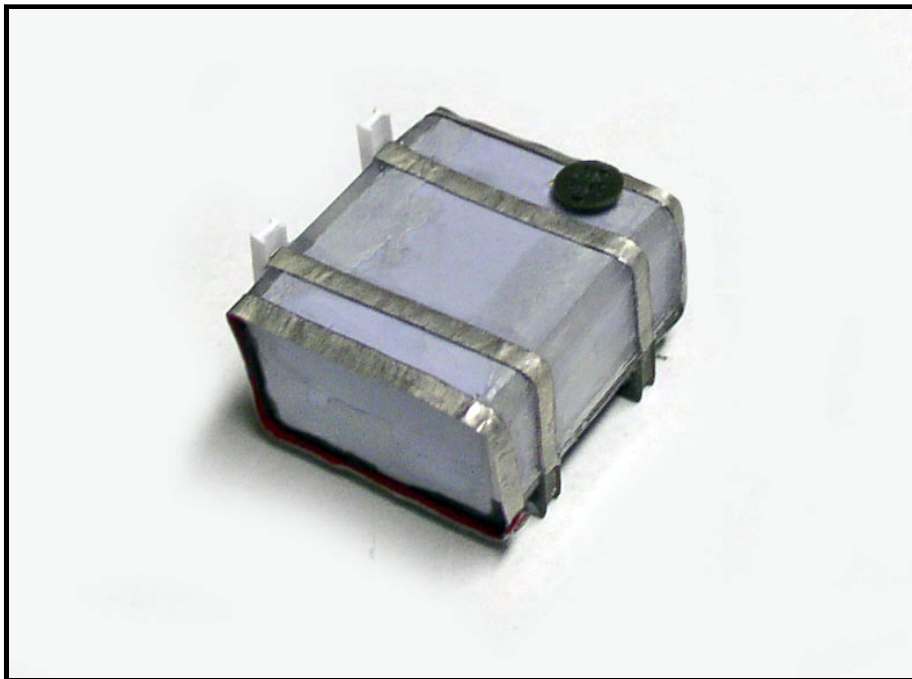
Manufacturing the tank based on a 923 part...

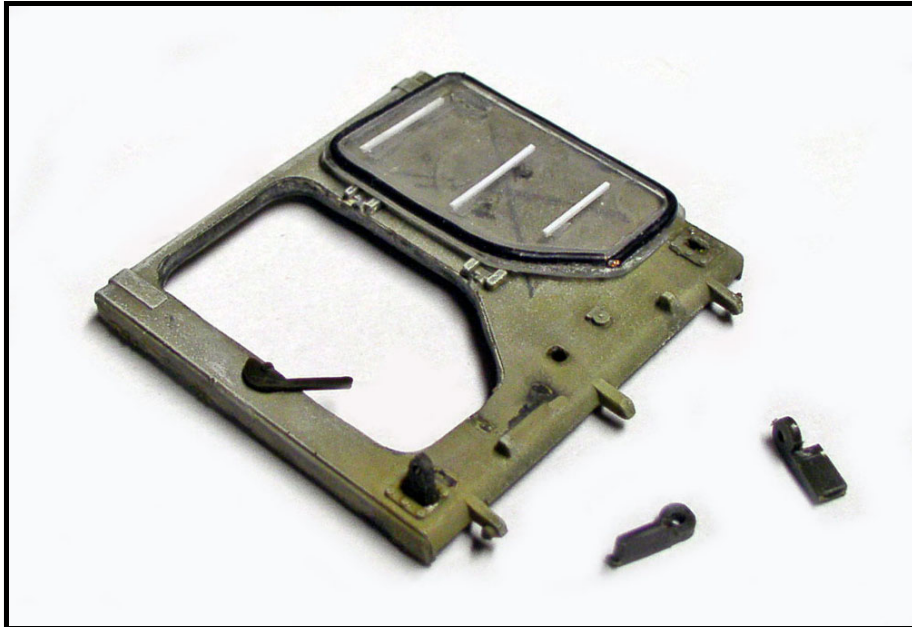
The door on the M113's hinged rear panel is cut out, while another is recreated using plastic sheet. A rubber gasket completes the assembly...

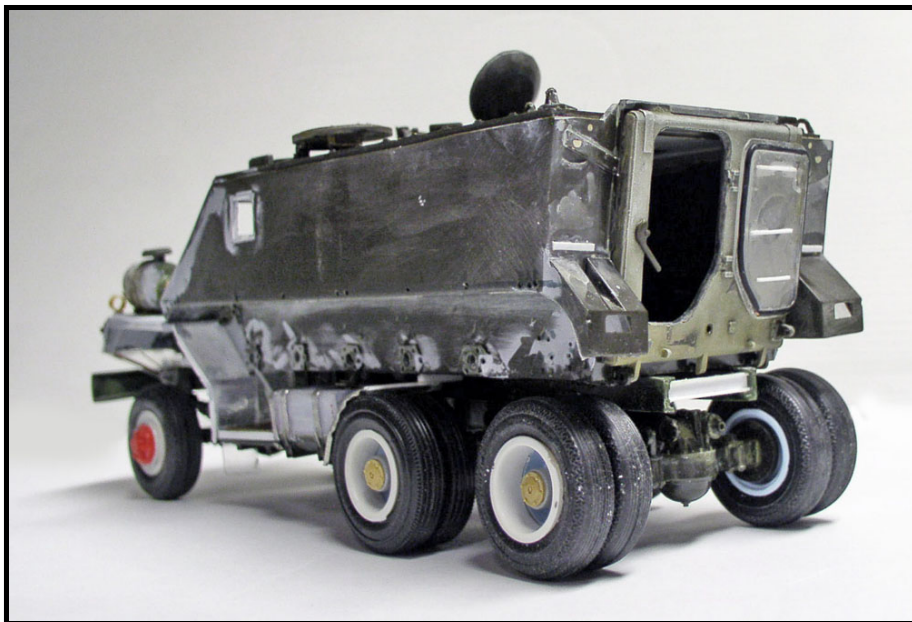
Installing the rear panel and the left side tank...

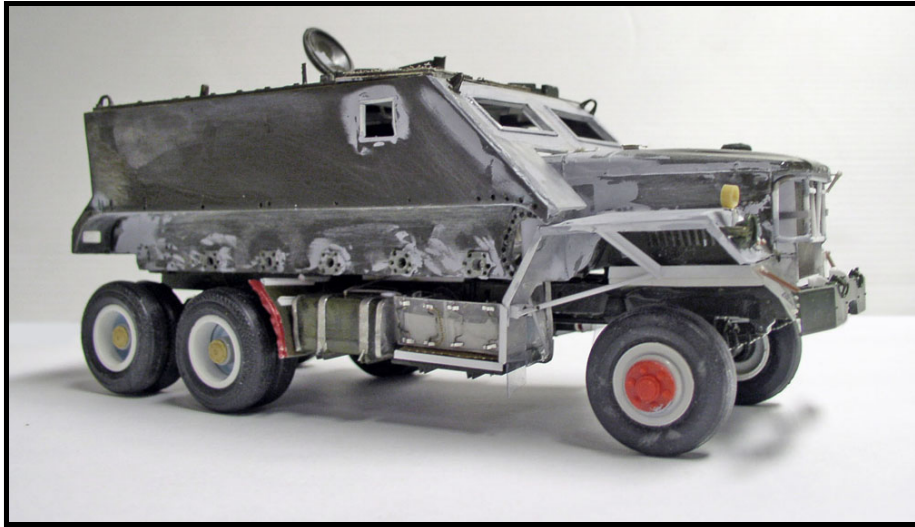
Installation of the battery box, the right-side fuel tank, and the rear fenders made of aluminum sheet...

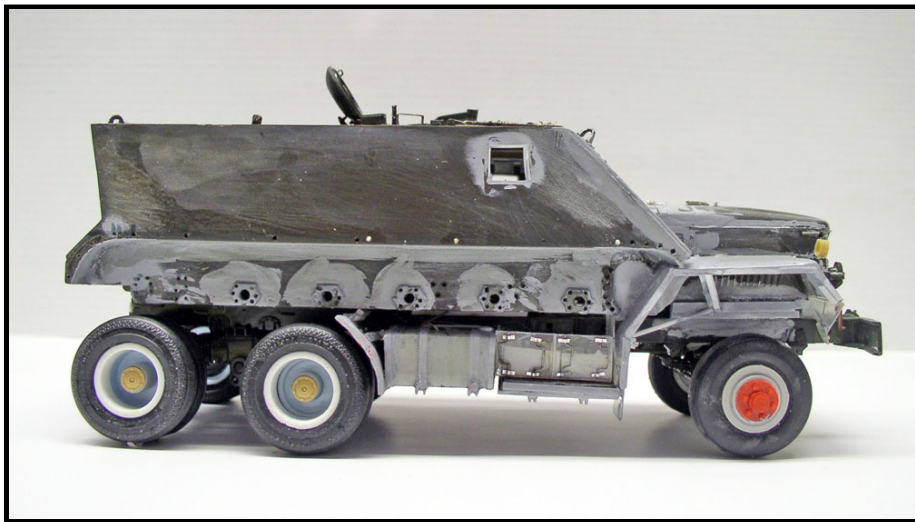
Installed the shock absorber guards on the M113 and drilled all the mounting holes one by one! Phew!

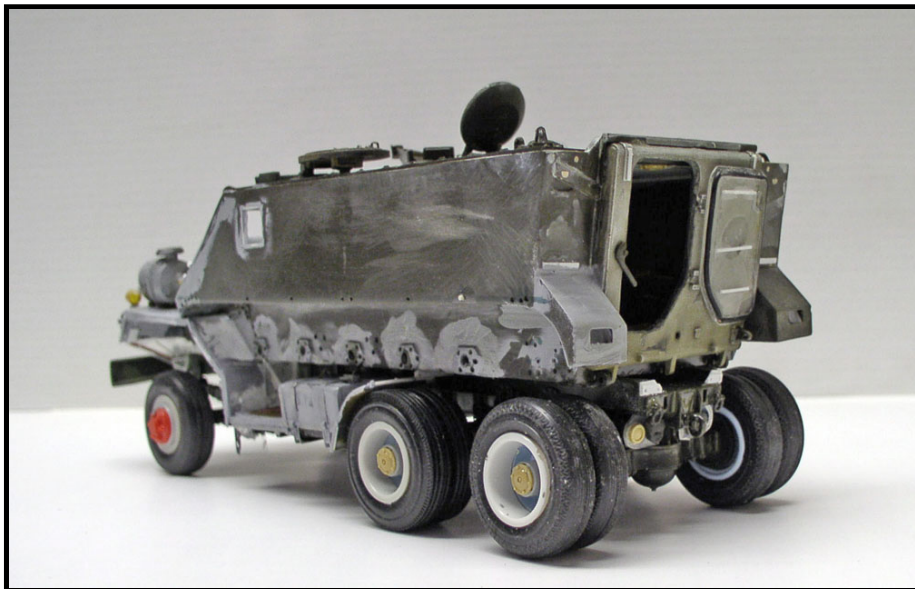
Installing the taillights on the chassis...

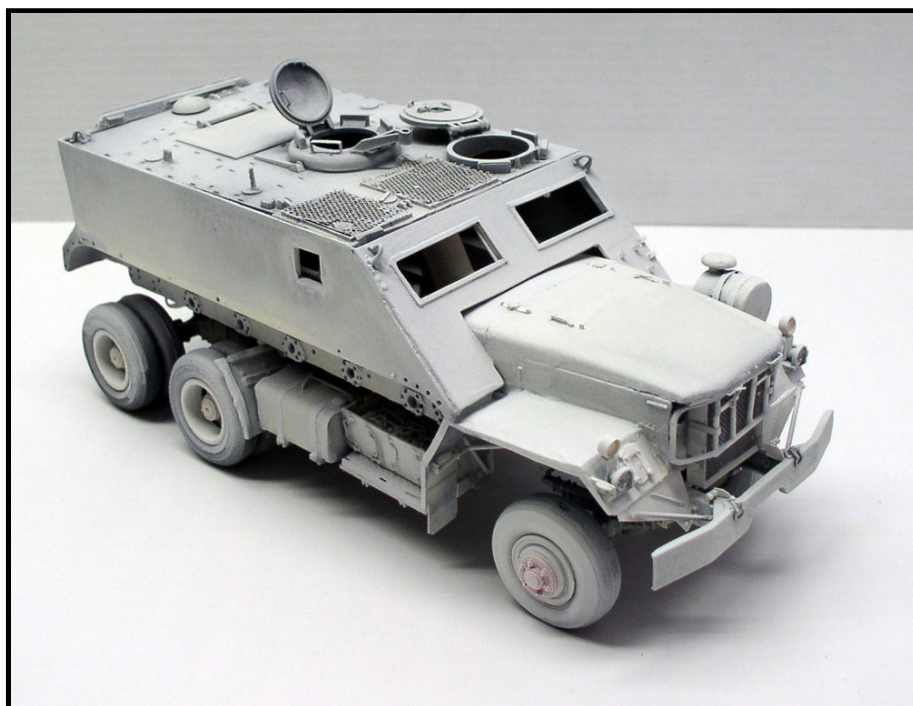
A coat of primer will reveal the many imperfections that aren't always visible during assembly...

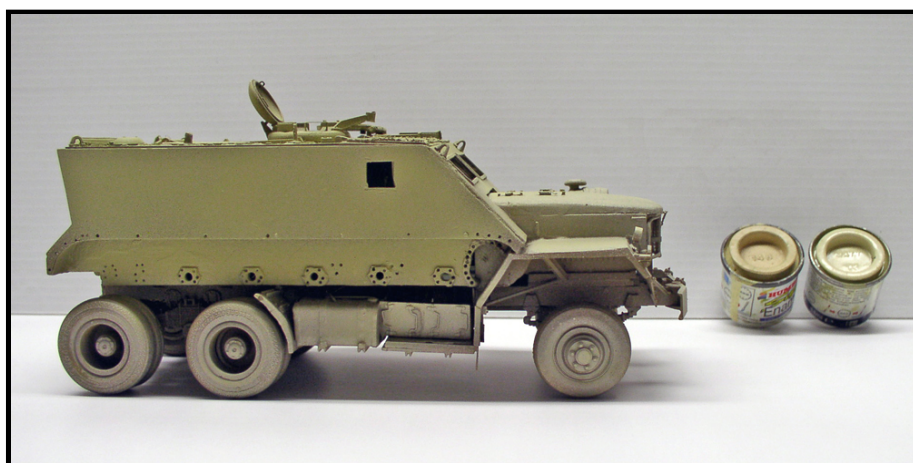
The paint used is Humbrol oil-based paint. Looking at photos of the actual vehicle, you can see that the 818 isn't the same shade as the M113—which is more yellow—while the M113 is more orange...

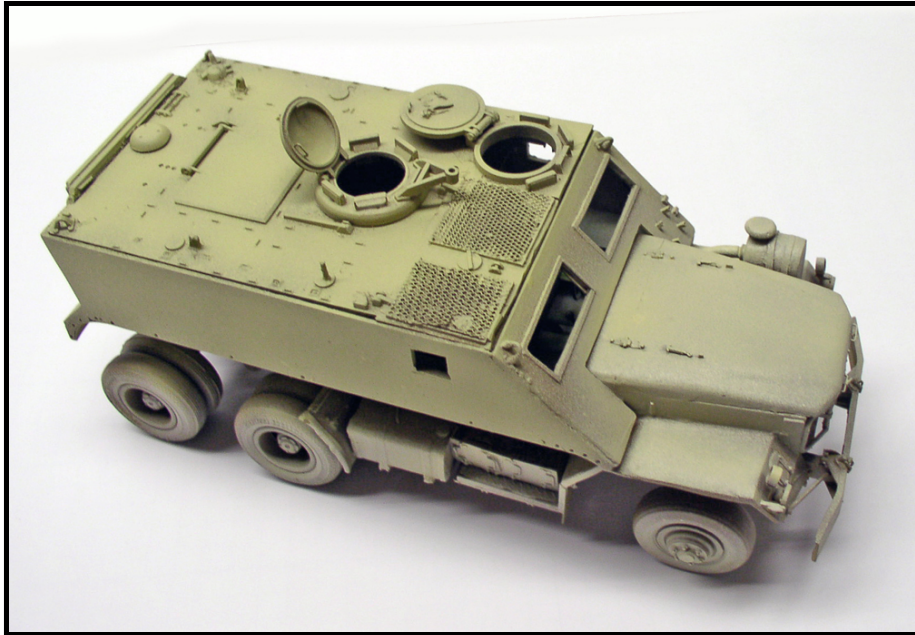
On a base of 110, the M113 is coated with a layer of 103, and the truck with 148...

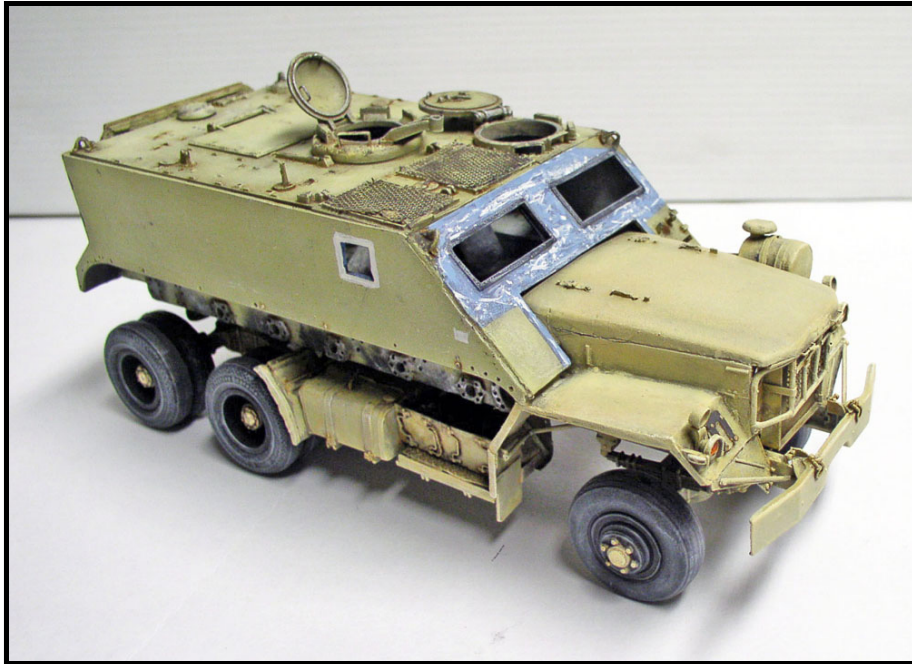
The model is painted with a black wash and 98 chocolate diluted to 60%, followed by a light dry-brush of 148 on the nose and sides, while 103 is used to finish the M113. Scratches are painted using light blue and white on the front of the windshield. The tractor is given a wash using 62 all over...

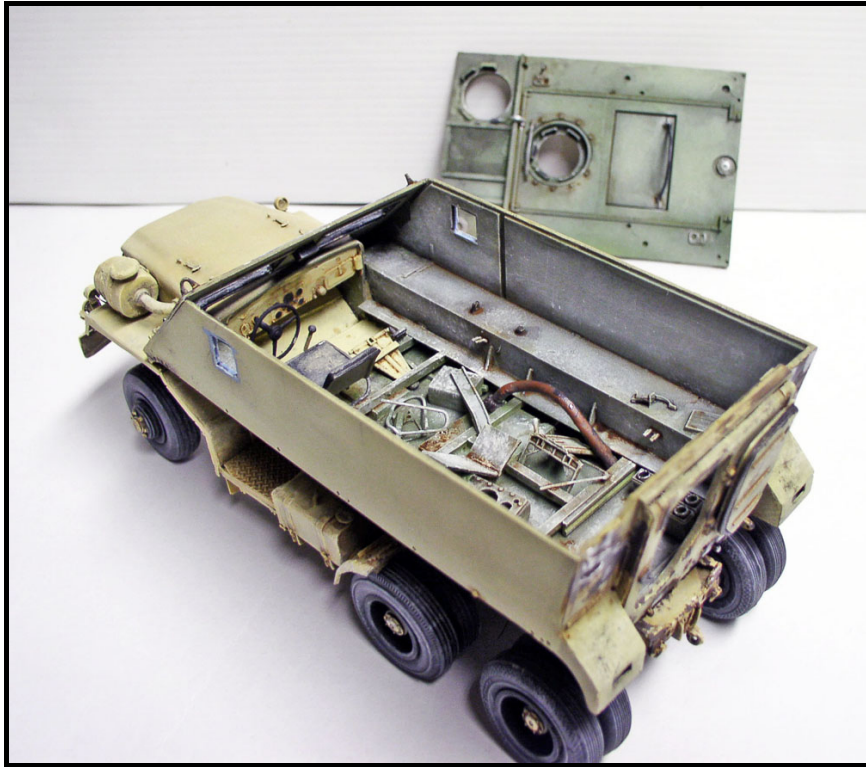
The interior of the M113 features various unfinished and abandoned parts. A base coat of 105 and 90 green will be applied, followed by a dry-brush with 23, which will then be lightened with white to complete the paint job. The truck's cab is painted with 148...

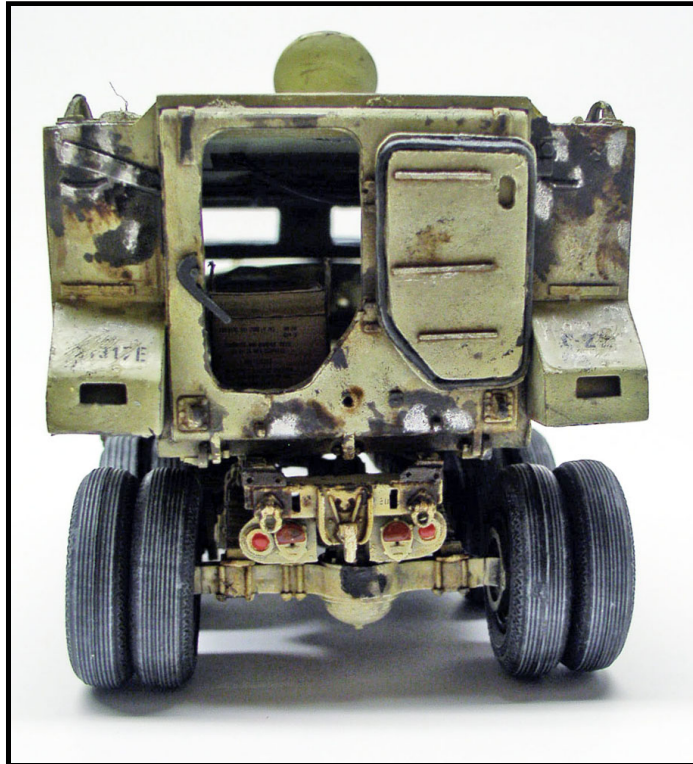
Rear view showing the grinding marks made on the aluminum and the various rust spots applied with a brush...

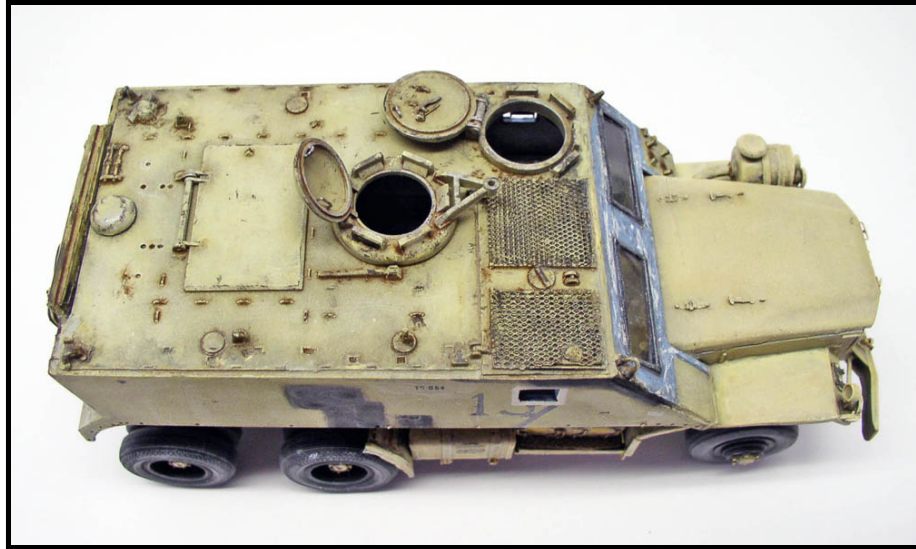
The effects of rust on the M113's hull are much more pronounced than on the tractor...

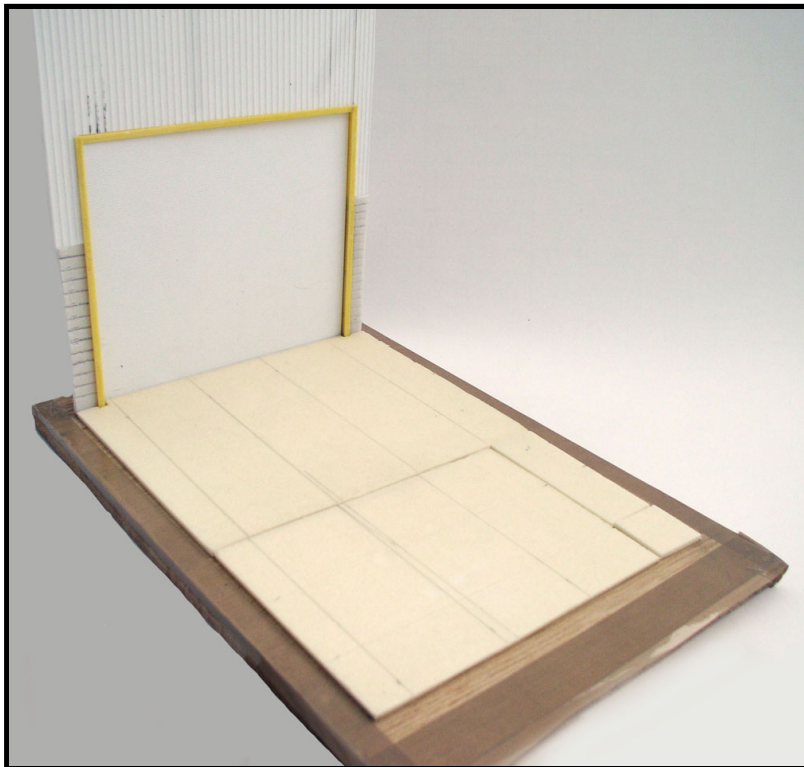
It's very simple and is built into the bottom of the hangar door in front of which the vehicle is parked. Extruded polystyrene forms the floor, while Evergreen sheets will simulate the door and the edges of the building...
